TO THE BID FOR: B023-11 Replacement of the Cedar Street Bridge (Bridge No. 04841) Over Harbor Brook – LOTCIP Project # L079-0003

BRIDGE NO.04841

46520 - MERIDEN
CEDAR STREET
over
HARBOR BROOK

Routine Inspection

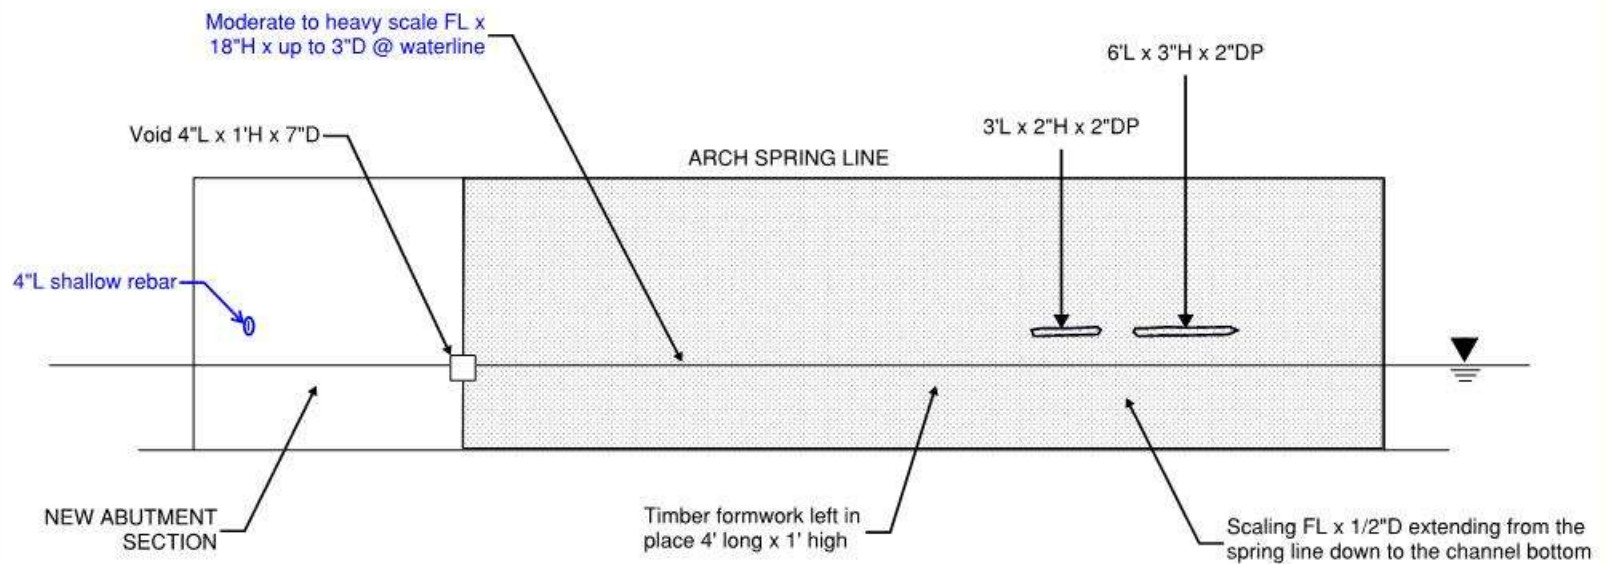
- Random areas of active leakage along the spring lines.
- Concrete overpour along spring line.
- Heavy accumulation of debris along abutment stem for full length @ waterline.

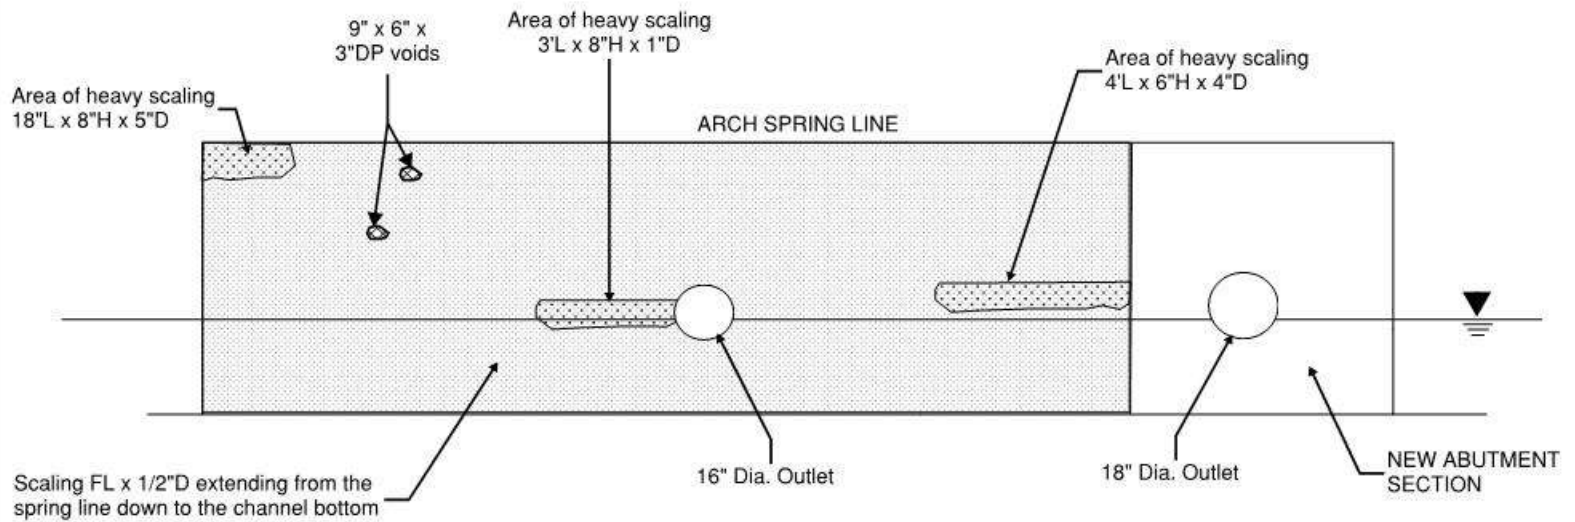
- Random areas of active leakage along the spring lines.
- Concrete overpour along spring line.

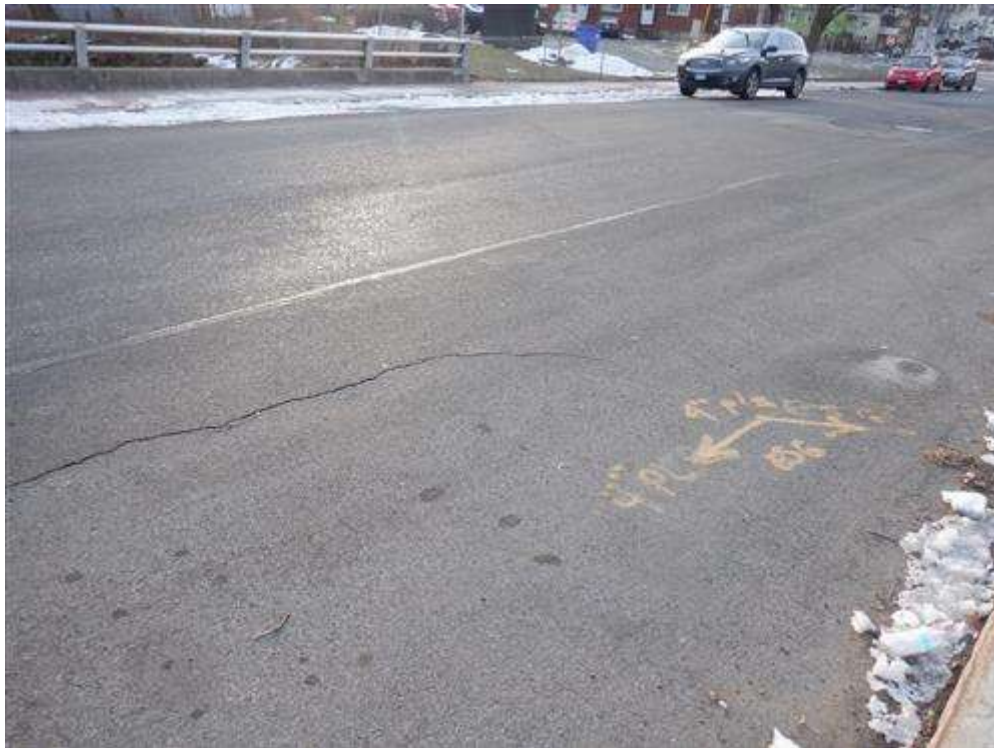
Photo Number: 8

Overlay: 7 The bituminous concrete pavement (over approximately 2' of fill material), has the following deficiencies:
- Random areas of light raveling.
- A 12.5' long x 12' wide bituminous patch at Abutment 1 has settled areas up to 4 square feet x 1" deep and cracks around the edges up to 1/4" wide.
- Paving seam in the southbound lane is open up to full length x 1/8" wide and is partially sealed.
- A 12' long x 1/4" wide longitudinal crack extends from the north approach, southbound lane.

Typical condition of the bituminous pavement over the bridge. Note the longitudinal crack extending from the approach pavement.

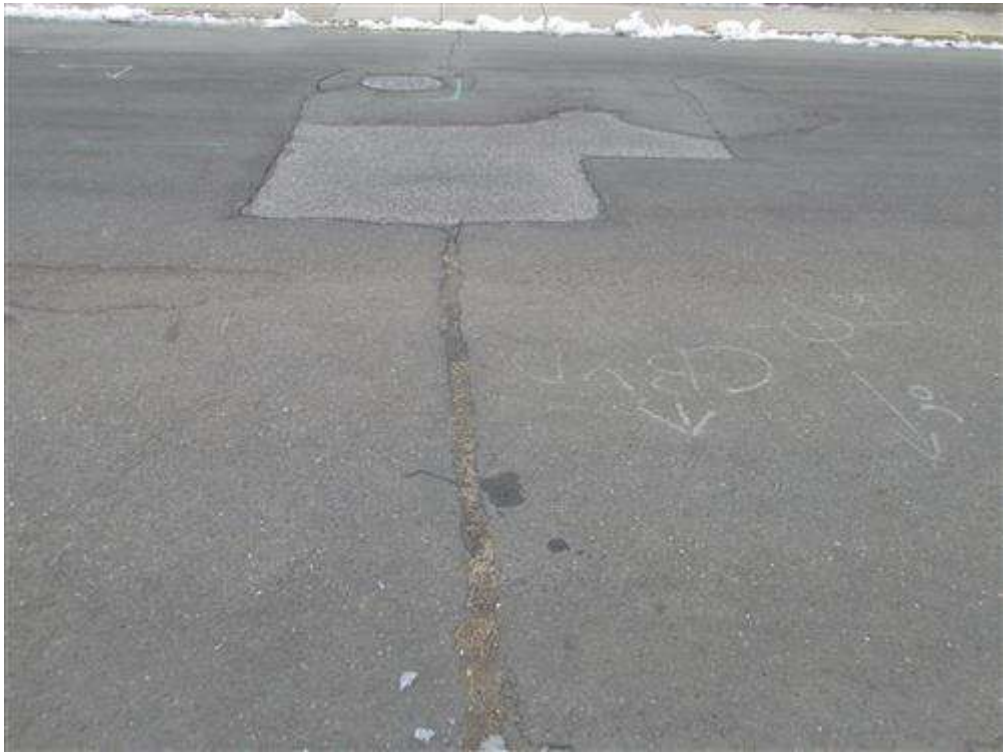
Photo Number: 9

Pavement at Abutment 1 has a transverse crack and a patch.

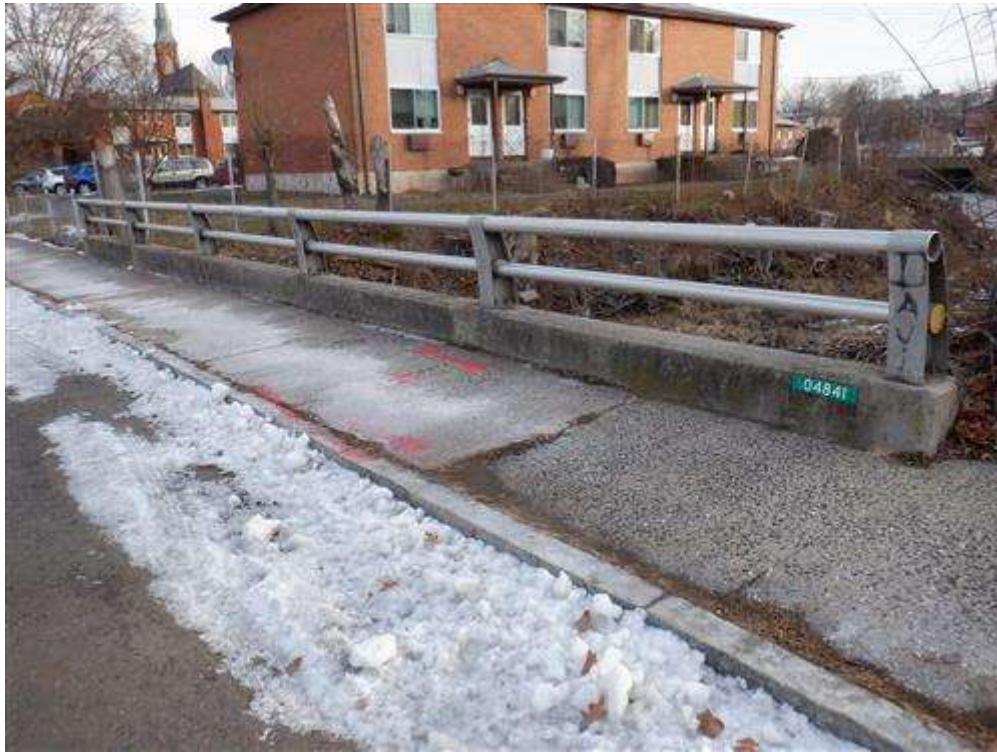
Photo Number: 11

East curb, sidewalk, rail base and railing.

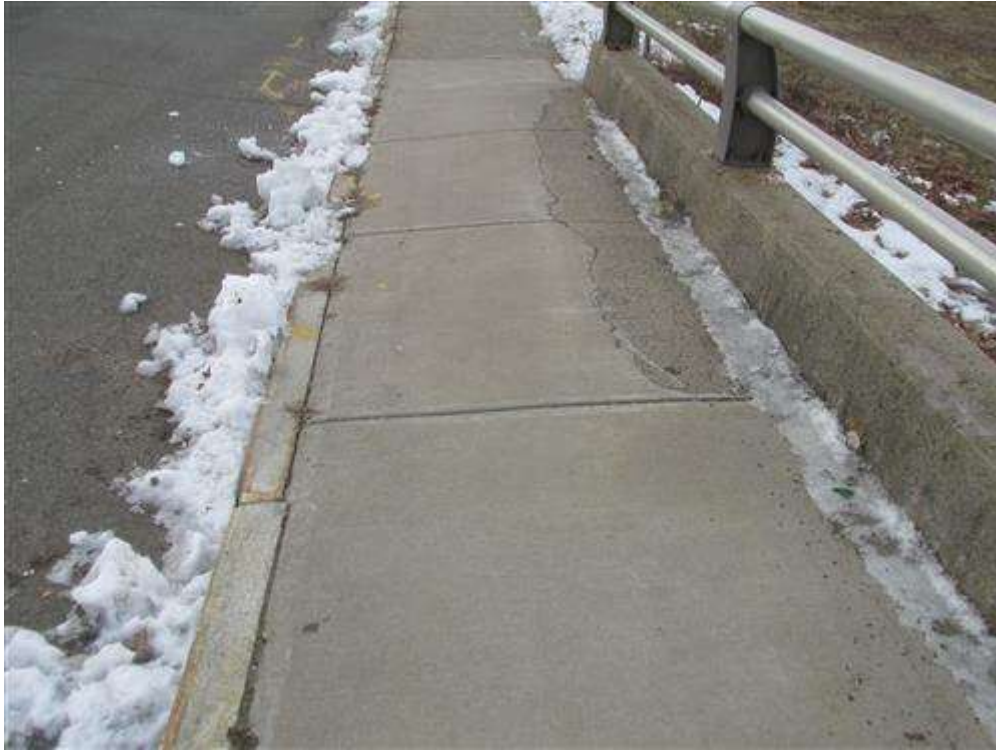
Photo Number: 13

Sidewalks: 6 Concrete sidewalks have the following:
- Random areas of light scaling in the old concrete .
- East sidewalk has vertical misalignment up to 1-1/2" between the 1st & 2nd panels from the south end (filled with dirt and vegetation growth). The 1st sidewalk panel from the south end has a 6" long x 1' wide x 1" deep spall.
- The south end of the west sidewalk is sloped downwards towards the curb.

West sidewalk at the south end is sloped downwards towards the roadway.

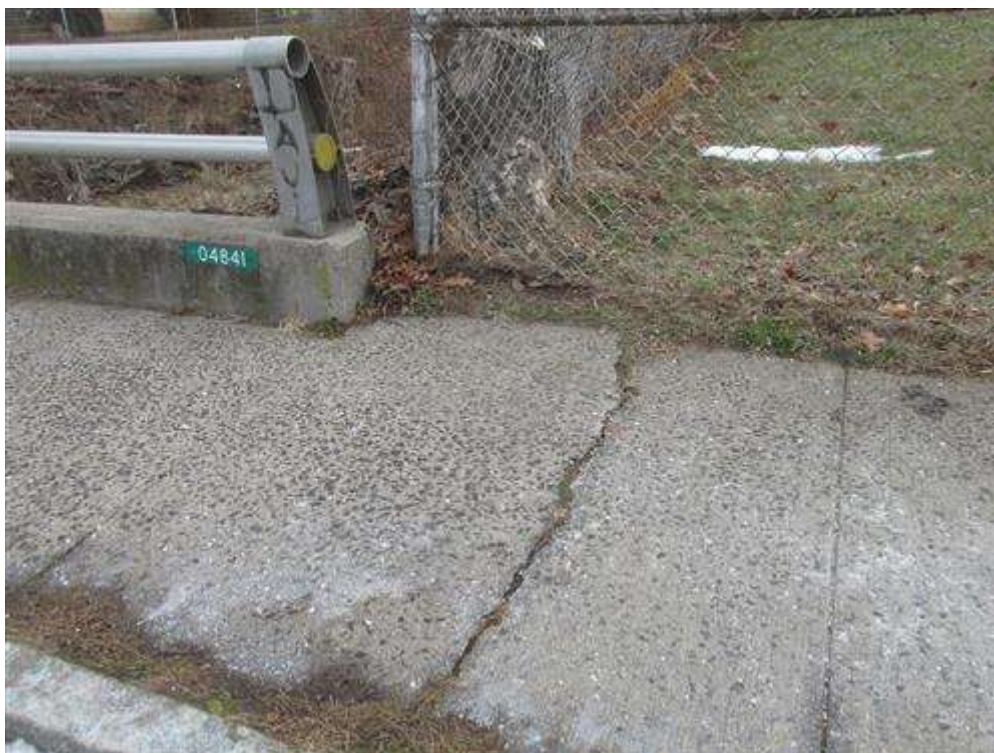
Photo Number: 15

- Areas of light scaling and transverse cracks up to 1" wide.
- The 1st panel from the bridge at the southeast corner has a full width transverse crack with a 1" vertical misalignment along the crack.
- Southeast approach sidewalk has three (3) cracks open up to 1" wide, starting from a manhole cover with the area between the cracks settled up to 1" deep.

Southeast approach sidewalk has vertical misalignment along the crack in the 1st section from the bridge.

Status: Open
Assigned To: ATB ATB
Work Item ID: 04841-2020-0001
Date Issued: 01/15/2020
Priority: Priority Repair
Deficiency: Sidewalk/ Safety Walk
Structural Component: Deck
Comments: Repair the vertical misalignment between adjacent sidewalk panels at the following locations:

- 1 inch high vertical misalignment (due to transverse crack) along the southeast approach sidewalk, at the 1st approach sidewalk panel from the bridge.
- 1 inch high vertical misalignment, with an adjacent 1 inch deep spall, along the east bridge sidewalk, between the 1st and 2nd sidewalk panels from the south end.

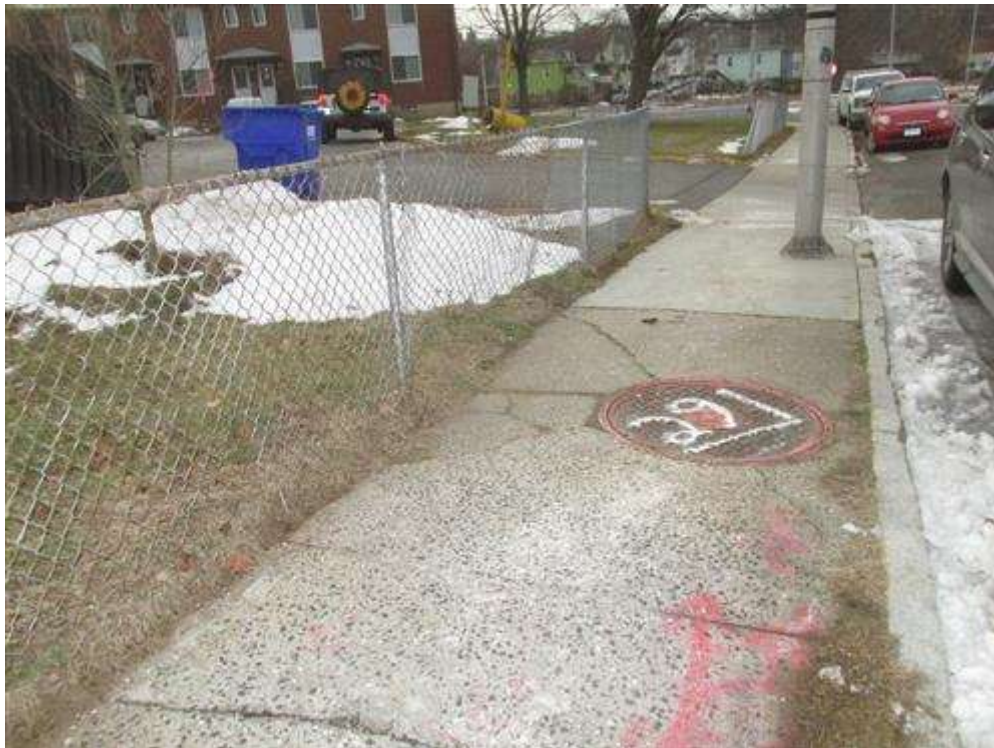
Photo Number: 16

Southeast approach sidewalk has cracks extending from the manhole. Also note the damaged chain link fence.

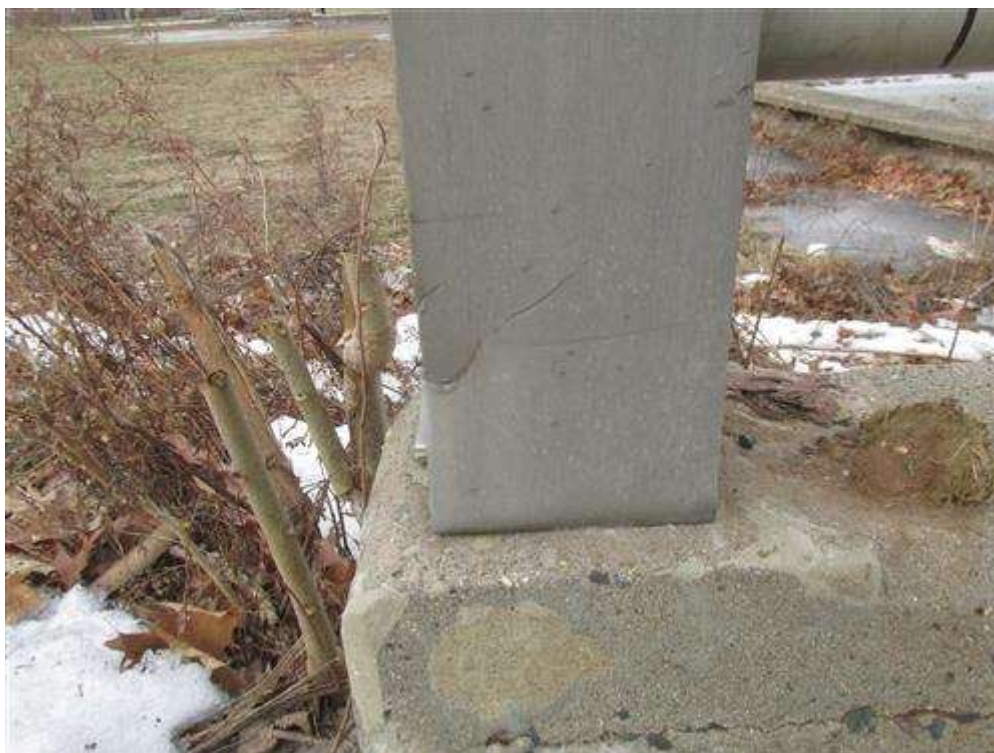
Photo Number: 17

- Isolated vertical hairline cracks. - A 1' long x 6" high x 1-1/2" deep spall in the outside face of the east rail base, at the north end. See sheets 15 & 16 and photos 10 & 11.
Railing: 6	Two pipe aluminum bridge railings have the following: - Random minor dents, scrapes and isolated areas of graffiti. - Pipe rail end caps are missing at the northeast, southeast and southwest corners of the bridge. - A few bent anchor bolts. - Random anchor bolt nuts are backed off by up to 1". - Isolated anchor bolts are missing washers. - A 1/2" high gap between rail base and end post at the north end of the west railing. - East railing has a 4" diameter x 1/4" deep dent between 3rd & 4th posts from the north end. - East railing, 2nd post from the north end has a dent with a 1" long tear and a missing anchor bolt nut. - West railing has a 1" long tear in the post at the south end. See sheets 15 & 16 and photos 10, 11 & 17-19.

West railing, South end post has a tear.

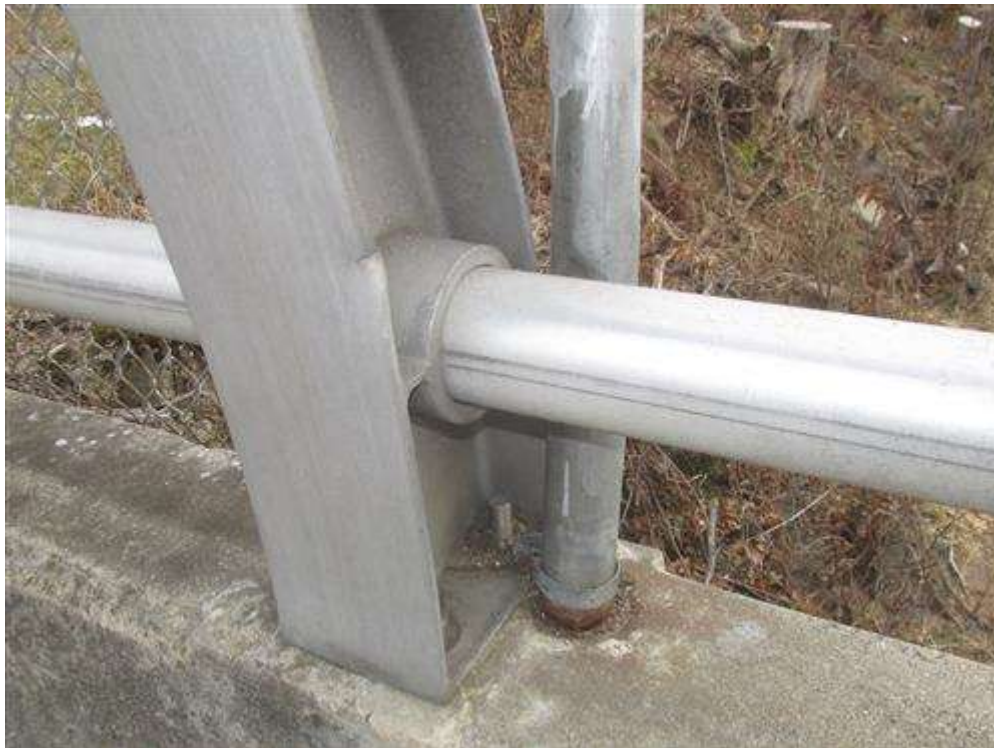
Photo Number: 18

East railing, second post from the north end has a missing anchor bolt nut.

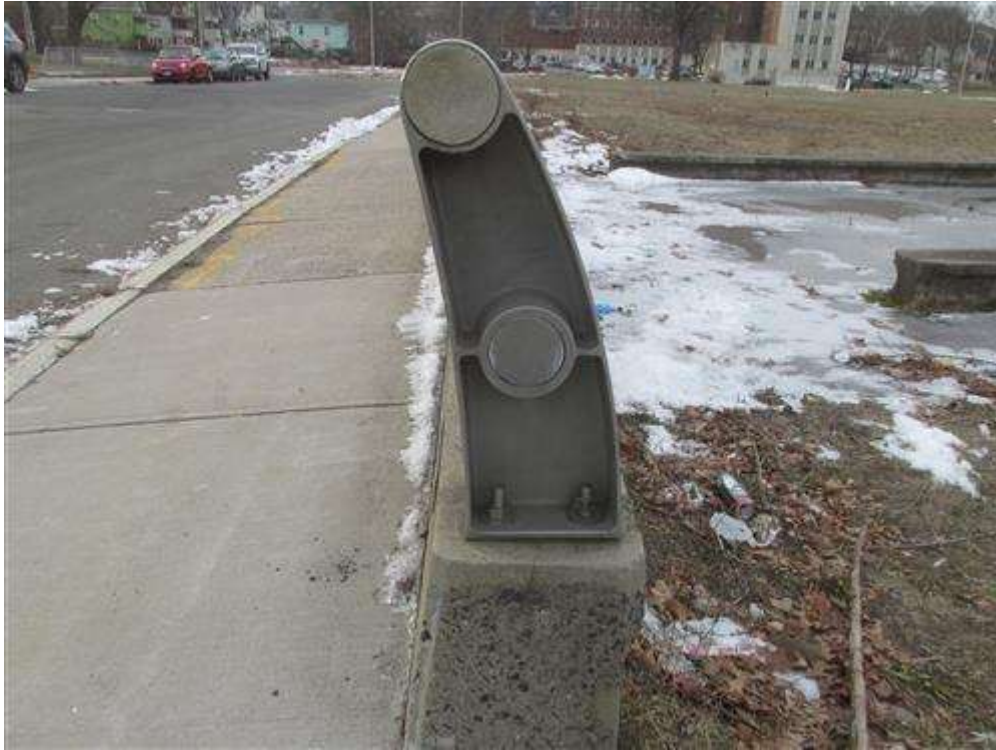
Photo Number: 19

West railing, North end post has a backed off anchor bolt nut and a gap between the base and rail base.

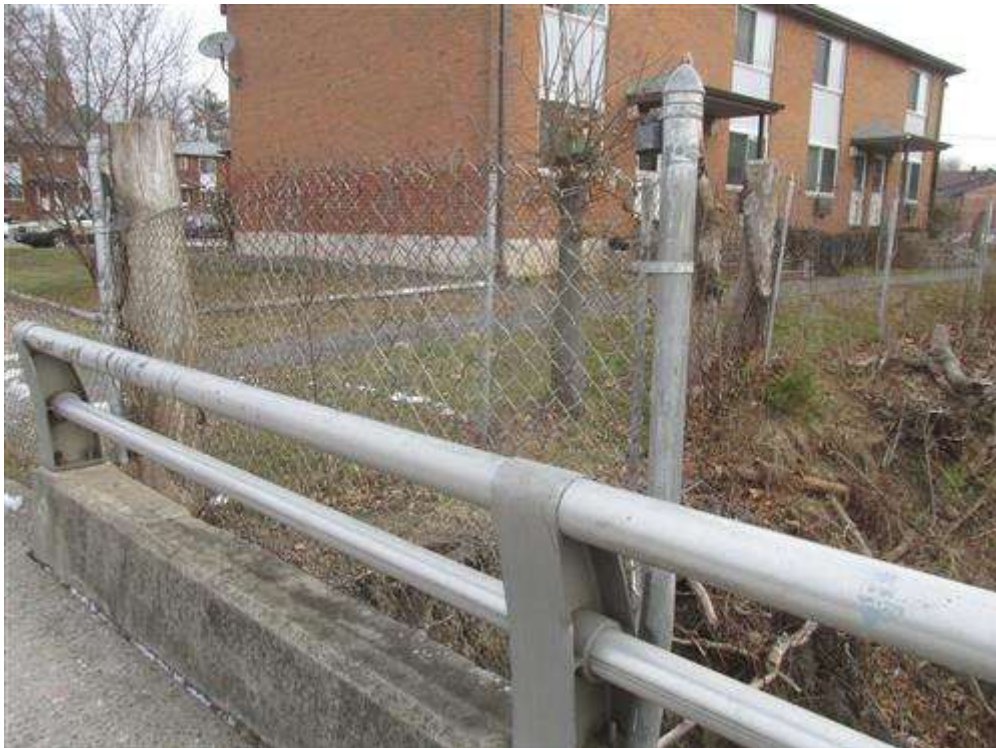
Photo Number: 20

Paint: N	
Fence: 6	Chain-link fence along the northeast and southeast corners of the bridge. - Random areas of light rust. - East fence has a missing top pipe between the 1st & 2nd railing posts from the north end. The fence is bent out at this location. - The 3rd panel from the north end of the southeast approach fence is bent for full length x 1' deep, with bent posts. See sheets 15 & 16 and photos 16 & 20.
Drains: N	
Lighting Standard: N	
Overall Utility Condition Rating	N - Not Applicable
Utility Type/Size	N No Utilities present

East fence at the north end has a missing top pipe rail.

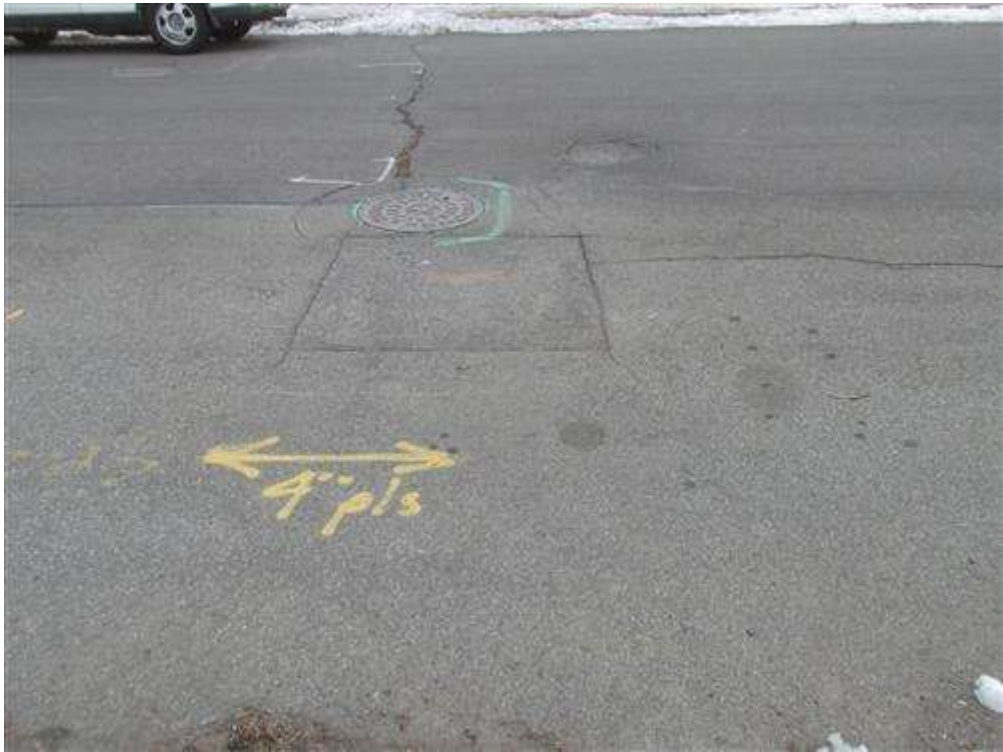
Photo Number: 21

North approach pavement near Abutment 2 has a transverse crack, a bituminous patch and two (2) depressed areas.

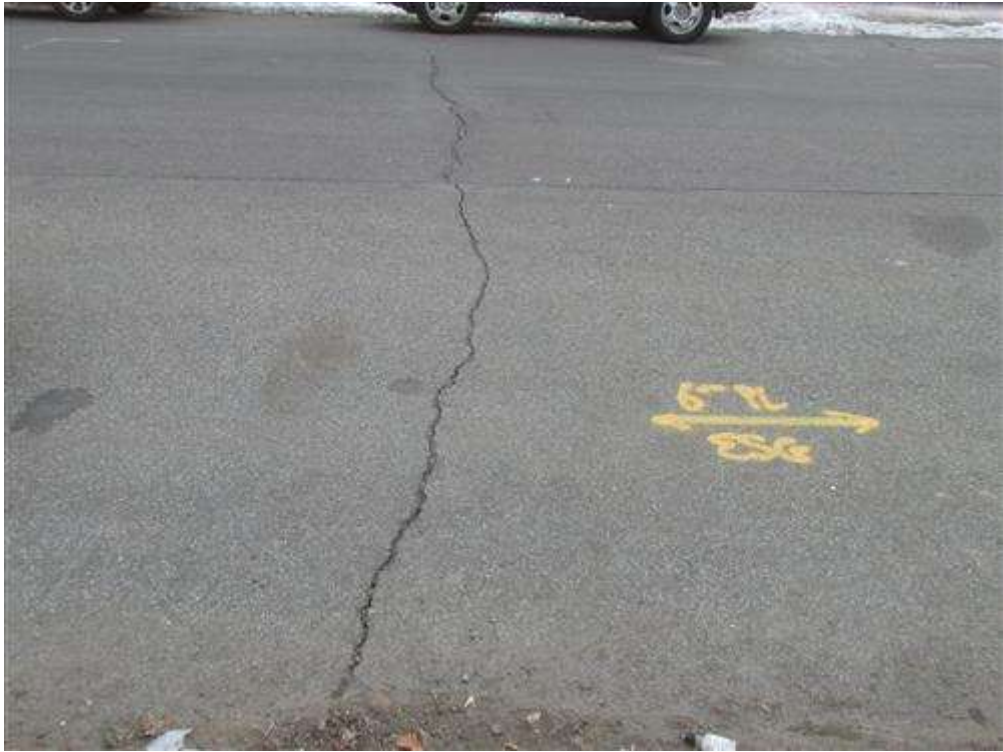
Photo Number: 22

Rating	
Approach Slab: N	
Relief Joints: N	
Approach Guide Rail: N	
Approach Pavement: 5	Bituminous pavement. North approach pavement has the following: - A 22' long transverse crack, open up to 3" wide, 3" deep and is filled with sand. - A full width x 1" wide transverse crack with edge raveling, at 30' from the bridge. - The area around the manhole cover is settled up to 1" deep. - Northbound lane has a 3' diameter bituminous patch settled up to 3" deep with edge raveling. - Southbound lane has a 2' diameter bituminous patch settled up to 2" deep. South approach pavement has two transverse cracks up to 10' long x 3" wide, which are filled with sand

North approach pavement has a full width transverse crack at 30' from the bridge.

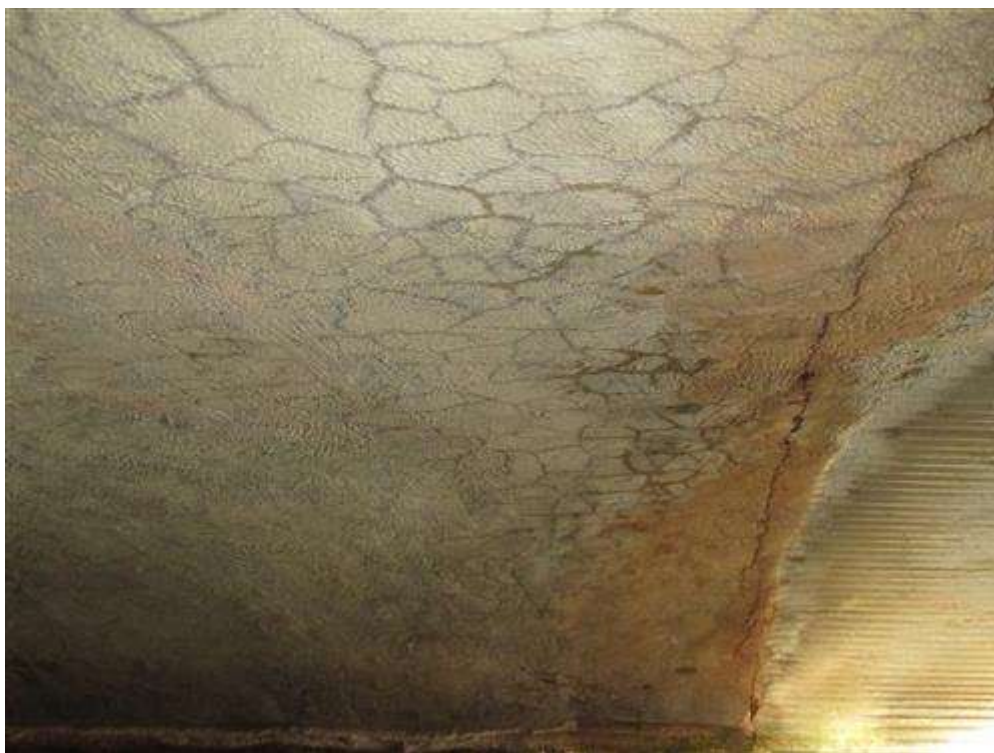
Photo Number: 25

- Random areas of hairline map cracking with and without efflorescence and dampness.
- Random hollow areas up to 100 square feet, primarily along the springlines.
- Isolated areas of scaling up to 4' long x 6" wide x up to 1" deep, with and without efflorescence, along the west end near Abutment 2.
- Active leakage up to 3' wide along the west edge at the crown.

Underside of the old concrete arch has areas of hairline map cracking.

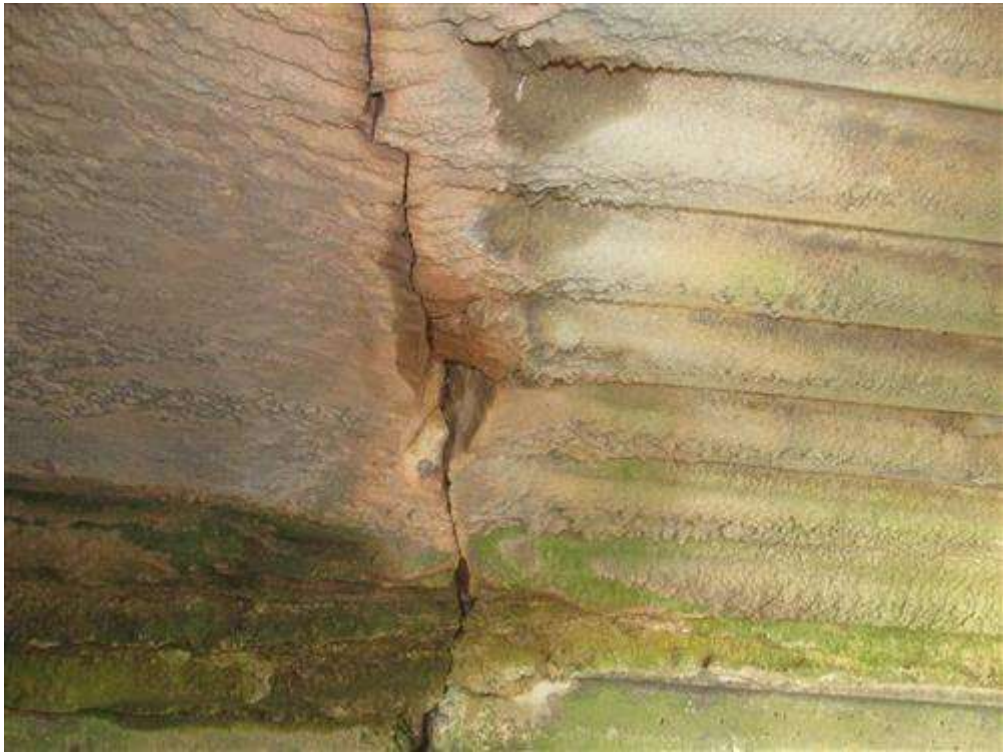
Photo Number: 27

The construction joint between the older and newer arch segments is open 1/8", with edge spalls up to 2" wide x 1" deep.

The joint between the older and newer concrete arch sections near Abutment 2 has a spall and leakage.

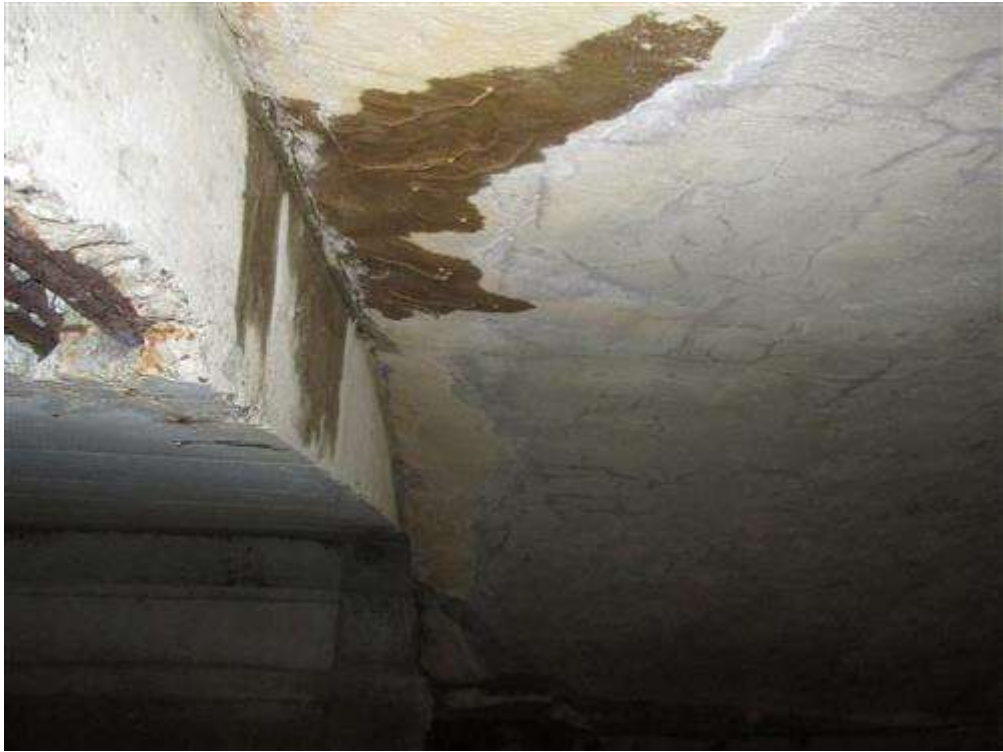
Photo Number: 28

The old concrete arch at the west end has active leakage at the crown.

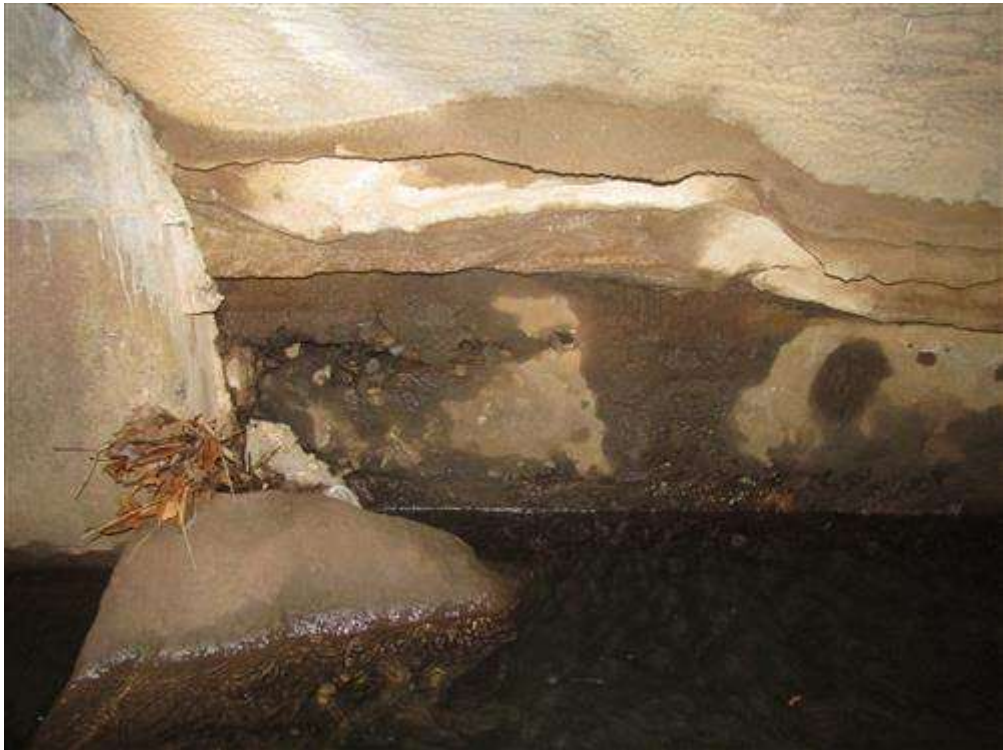
Photo Number: 31

Abutments - Stem:	5	<p>The concrete abutment stems have the following deficiencies:</p> <ul style="list-style-type: none"> - Old concrete arch section has areas of scaling up to full length x 1/2" deep, extending from the springline to the channel bottom. - Several areas of moderate to heavy scaling, up to full length x 18" high x 3" deep in the old concrete arch section, along with isolated areas of scaling up to 18" long x 8" high x 5" deep. - A 4" long x 1' high x 7" deep void, along the construction joint between the older and newer sections at Abutment 1. <p>See sheet 18 & 19 and photos 29-32.</p>
Abutments - Backwall:	N	
Abutments - Footings:	N	Not visible.
Abutments - Settlement:	8	None observed.
Abutments - Wingwalls:	N	<p>Dry-laid stone retaining walls along the upstream channel.</p> <p>Northeast retaining wall is covered with bituminous concrete for 15' long adjacent the structure.</p> <p>Southeast retaining wall has the following:</p> <ul style="list-style-type: none"> - Near the bridge, the wall is bulging out 2' towards the channel for approximately 10' long x full wall height (a previously noted condition). - Growth of vegetation and trees along the base. - The wall has collapsed approximately 75' from the bridge (a previously noted condition). <p>See sheet 20 and photo 33.</p>

Abutment 2 at the west end has scaling.

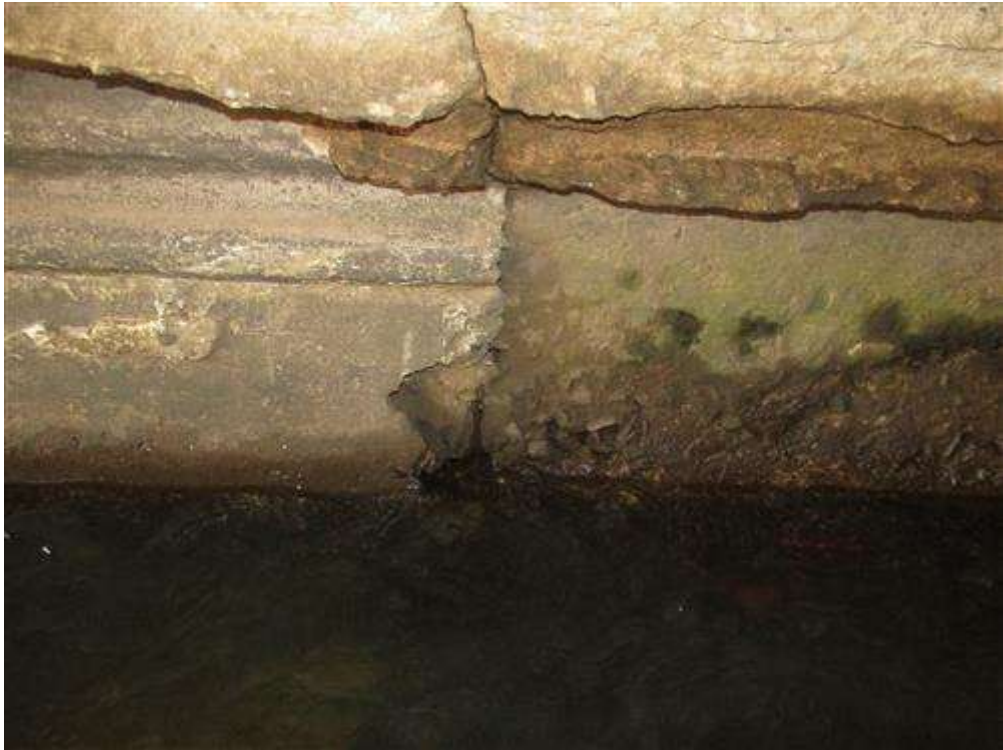
Photo Number: 32

Abutment 1 along the joint between the older and newer concrete arch sections has a void.

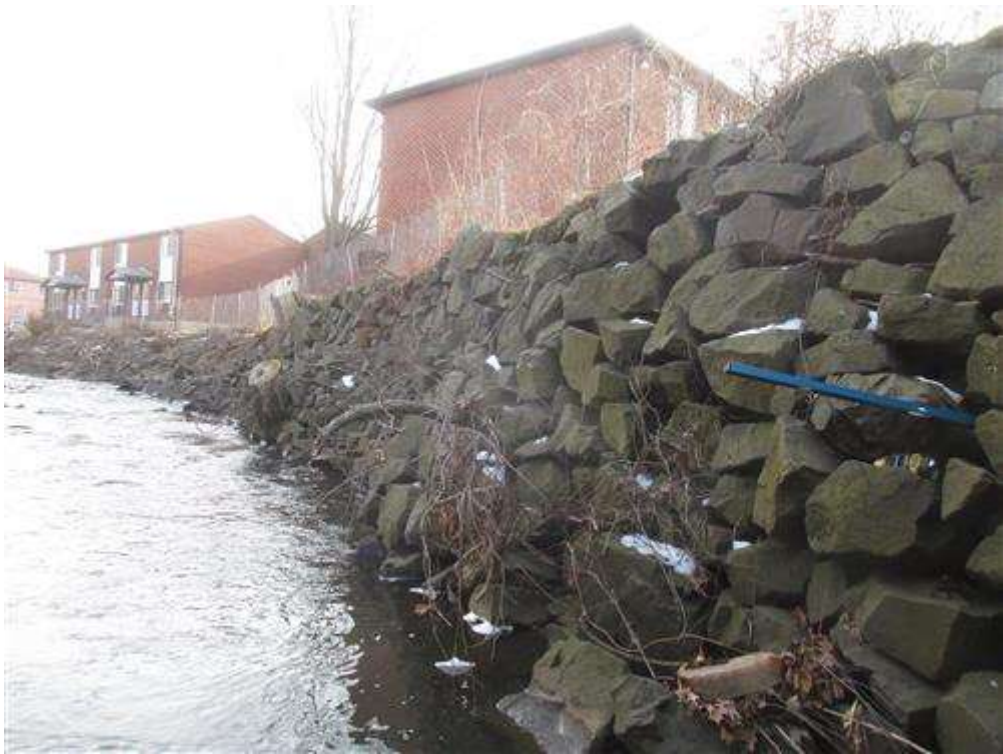
Photo Number: 33

Dry-laid stone retaining wall at the southeast corner of the structure has a section that is bulging out.

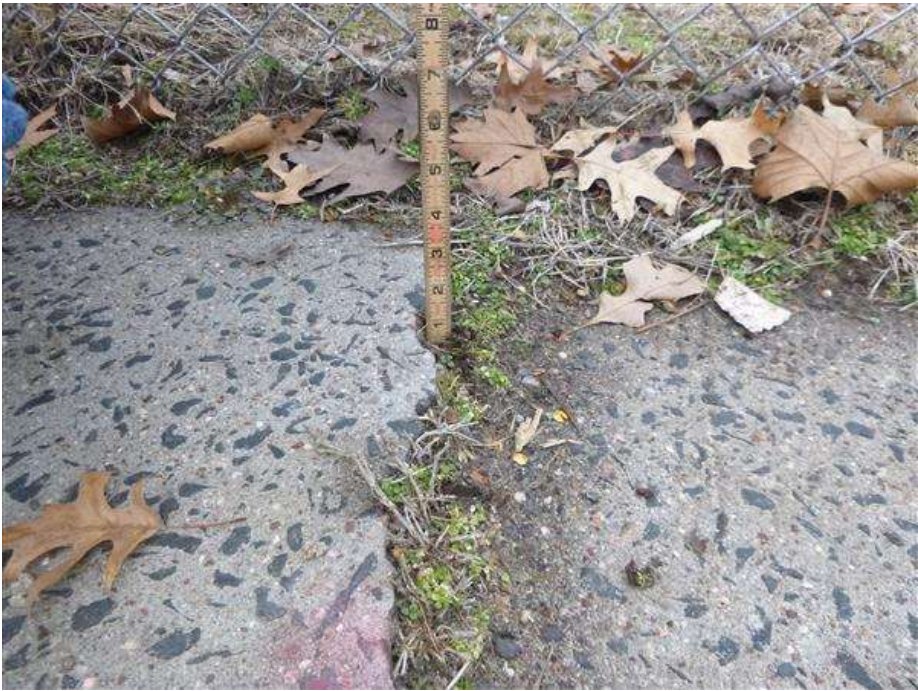
Vertical misalignment along the southeast approach sidewalk (due to crack), at the 1st approach sidewalk panel from the bridge.
