**Hazardous Building Materials Inspection Report  
City of Meriden  
Traffic Signal Improvements  
Meriden, CT**

**November 24, 2020  
Freeman File No: 2018-0108**

**RE: Hazardous Building Materials Survey for Traffic Signal Improvements**  
**Location: 11 Intersections, Meriden, CT**  
**Freeman Companies Project #: 2016-0910**

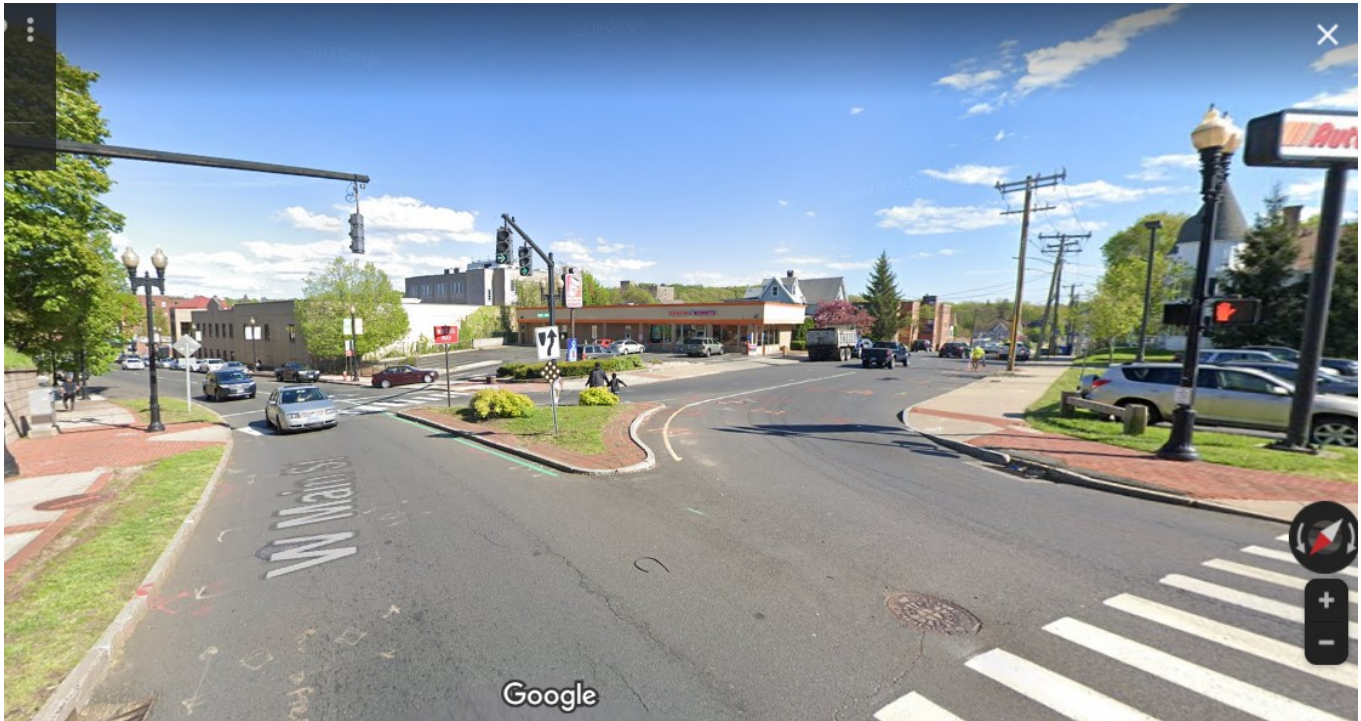
Intersection #1. Image taken from Google Street View (Image Capture May 2019)

- Two (2) span poles were metal (painted black). Three (3) light poles were metal (painted black). Five (5) traffic signals were metal (painted black). Six (6) pedestrian signal hoods were metal (painted black).

- Although several elements were painted, the substrate on painted surfaces was metal; any waste generated would be classified as non-hazardous, non-RCRA waste and can be recycled.

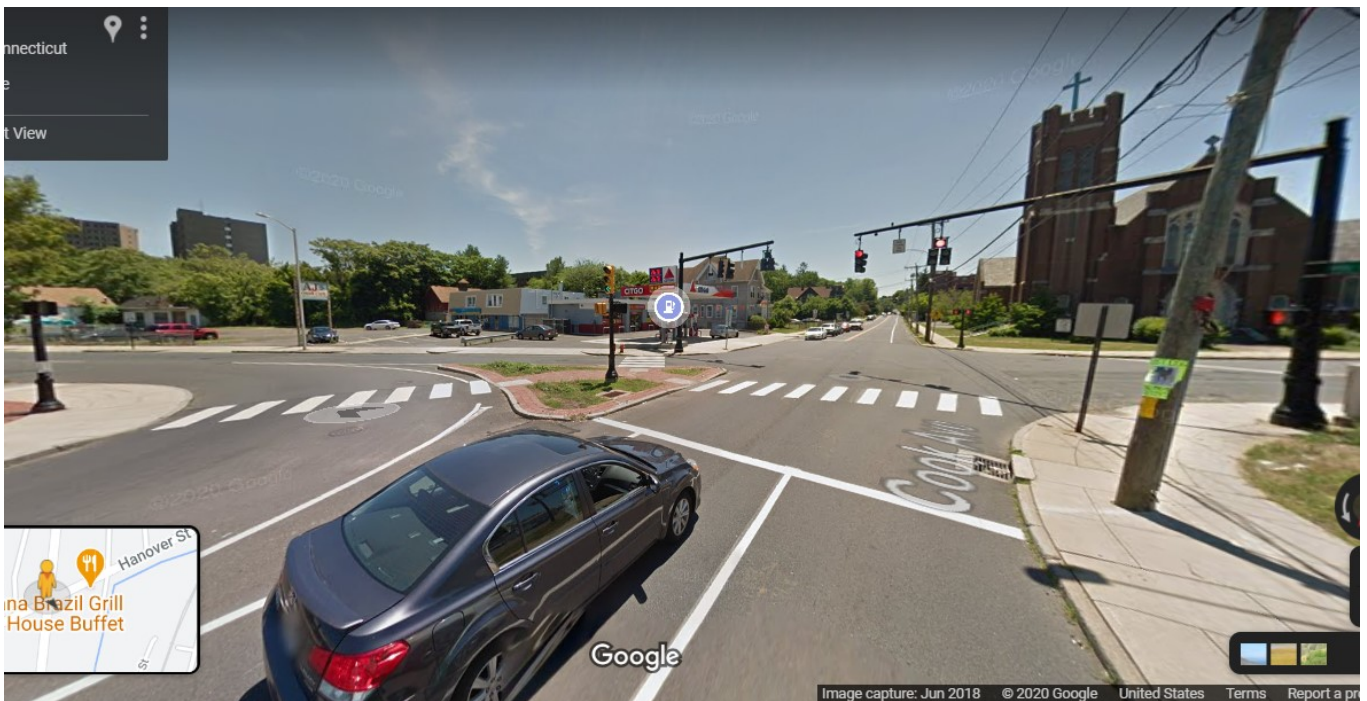
Intersection #2. Image taken from Google Street View (Image Capture May 2019)

- Two (2) span poles were metal (painted black). Six (6) traffic signals were metal (painted black and yellow). Three (3) pedestrian signal pedestals were metal (painted black), and nine (9) pedestrian signal hoods were metal (painted black). One (1) traffic controller cabinet was galvanized (unpainted).

- Although several elements were painted, the substrate on painted surfaces was metal; any waste generated would be classified as non-hazardous, non-RCRA waste and can be recycled.

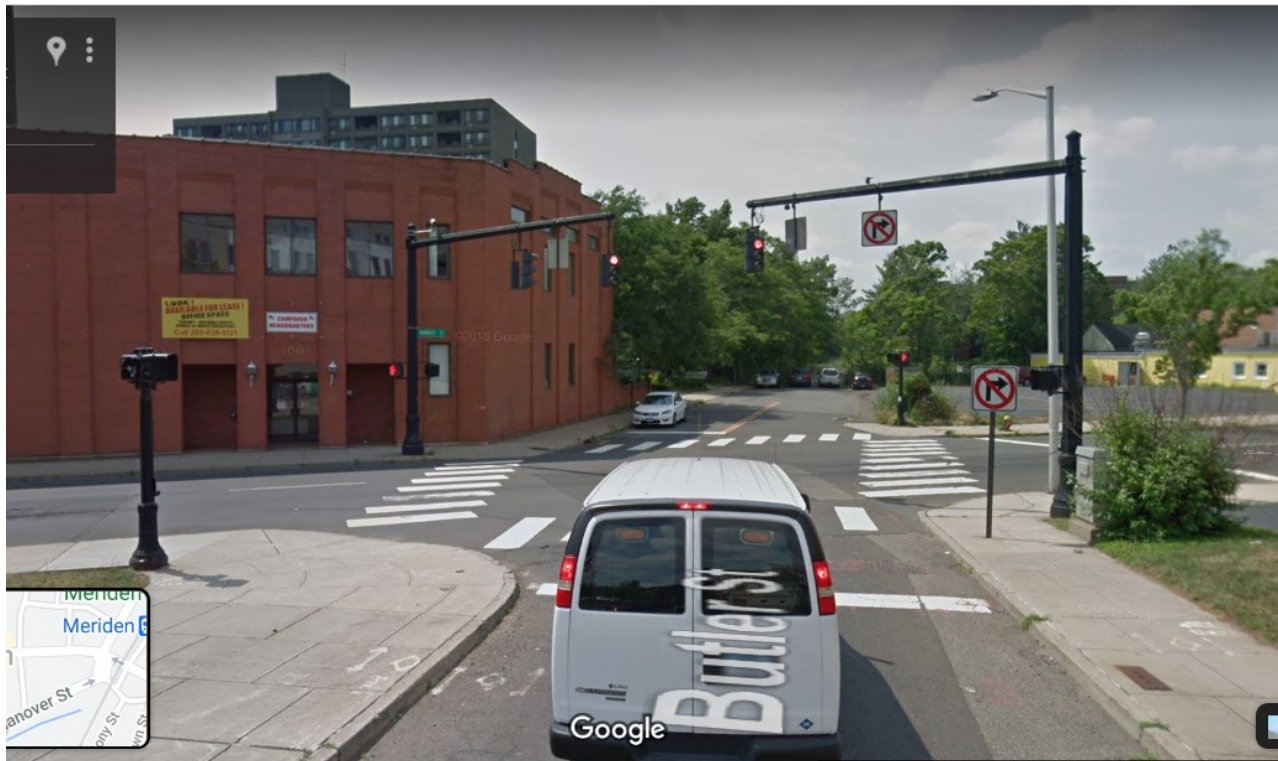
Intersection #4. Image taken from Google Street View (Image Capture May 2019)

- Two (2) span poles were metal (painted black). Six (6) traffic signals were metal (painted black). Two (2) pedestrian signal pedestals were metal (painted black), and eight (8) pedestrian signal hoods were metal (painted black). One (1) traffic controller cabinet was galvanized (unpainted). One mounted camera was metal (unpainted).

- Although several elements were painted, the substrate on painted surfaces was metal; any waste generated would be classified as non-hazardous, non-RCRA waste and can be recycled.

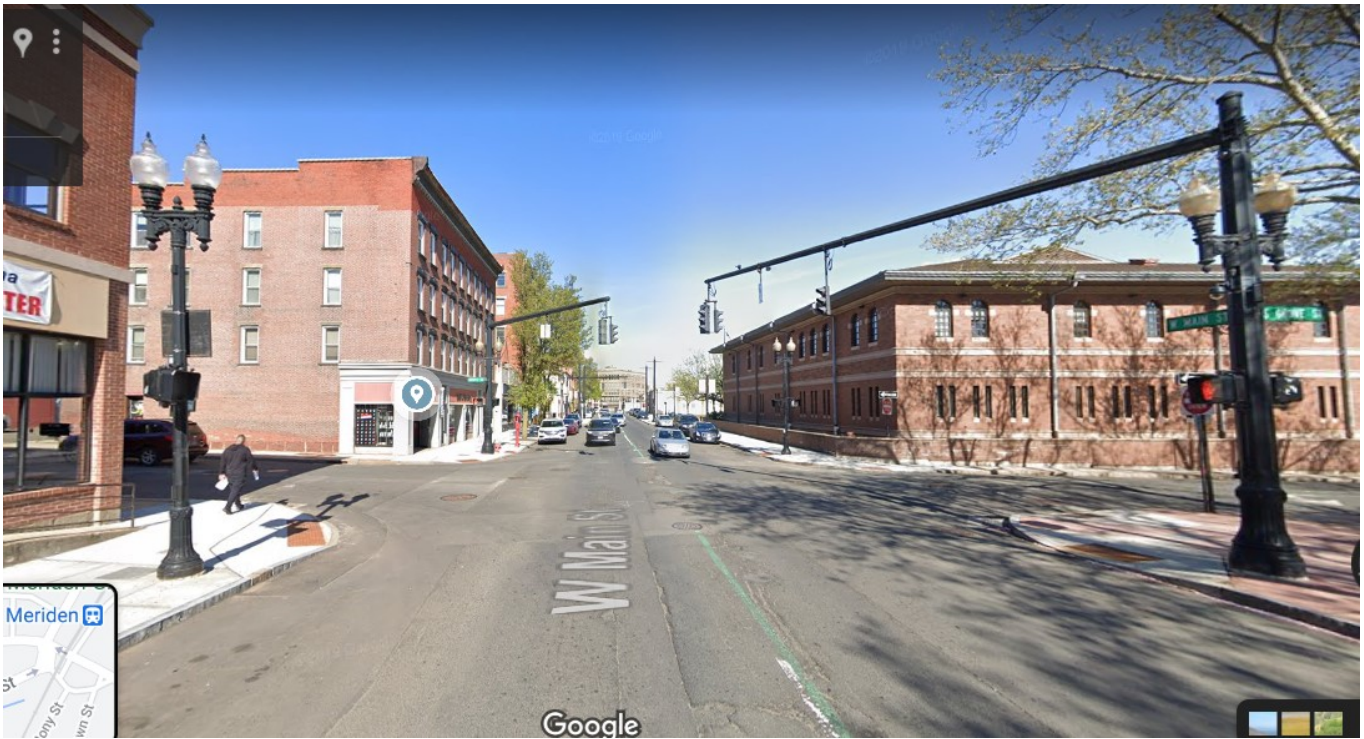
Intersection #5. Image taken from Google Street View (Image Capture May 2019)

- Two (2) span poles were metal (painted black). Two (2) light poles were metal (painted black). Six (6) traffic signals were metal (painted black). Eight (8) pedestrian signal hoods were metal (painted black).

- Although several elements were painted, the substrate on painted surfaces was metal; any waste generated would be classified as non-hazardous, non-RCRA waste and can be recycled.

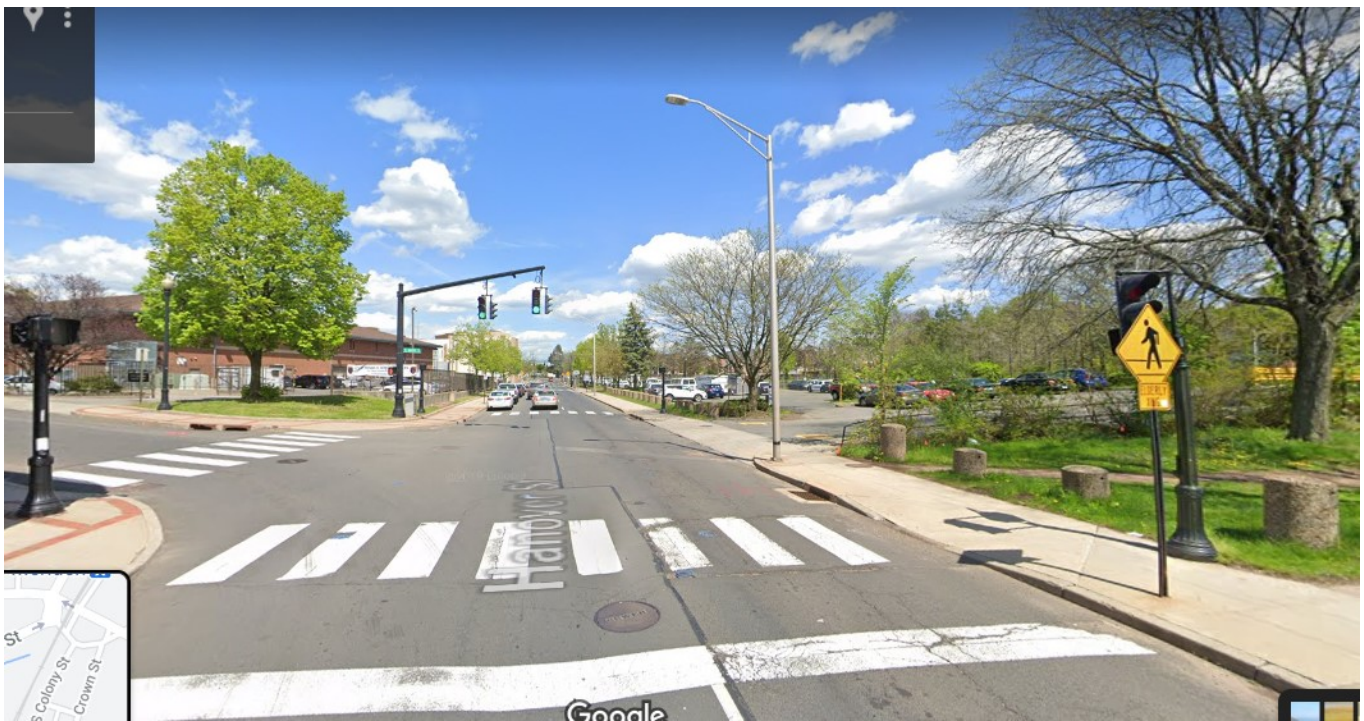
Intersection #6. Image taken from Google Street View (Image Capture May 2019)

- One (1) span pole was metal (painted black). One (1) light pole was galvanized (unpainted) and two (2) light poles were metal (painted black). Five (5) traffic signals were metal (painted black). Three (3) pedestrian signal pedestals were metal (painted black), and five (5) pedestrian signal hoods were metal (painted black). One (1) traffic controller cabinet was galvanized (unpainted).

- Although several elements were painted, the substrate on painted surfaces was metal; any waste generated would be classified as non-hazardous, non-RCRA waste and can be recycled.

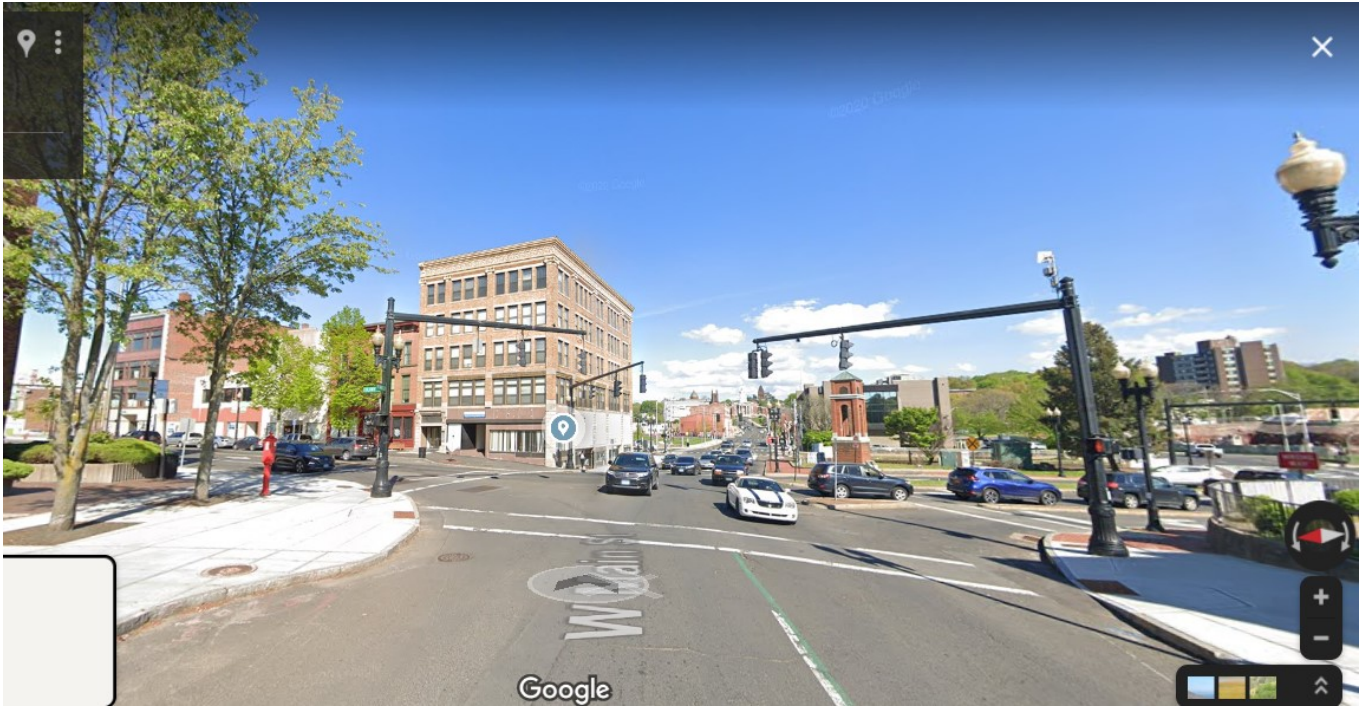
Intersection #7. Image taken from Google Street View (Image Capture May 2019)

- Three (3) span poles were metal (painted black). Four (4) light poles were metal (painted black). Eight (8) traffic signals were metal (painted black). Eight (8) pedestrian signal hoods were metal (painted black). One (1) traffic controller cabinet was galvanized (unpainted). One fire emergency pole was metal (painted red).

- Although several elements were painted, the substrate on painted surfaces was metal; any waste generated would be classified as non-hazardous, non-RCRA waste and can be recycled.

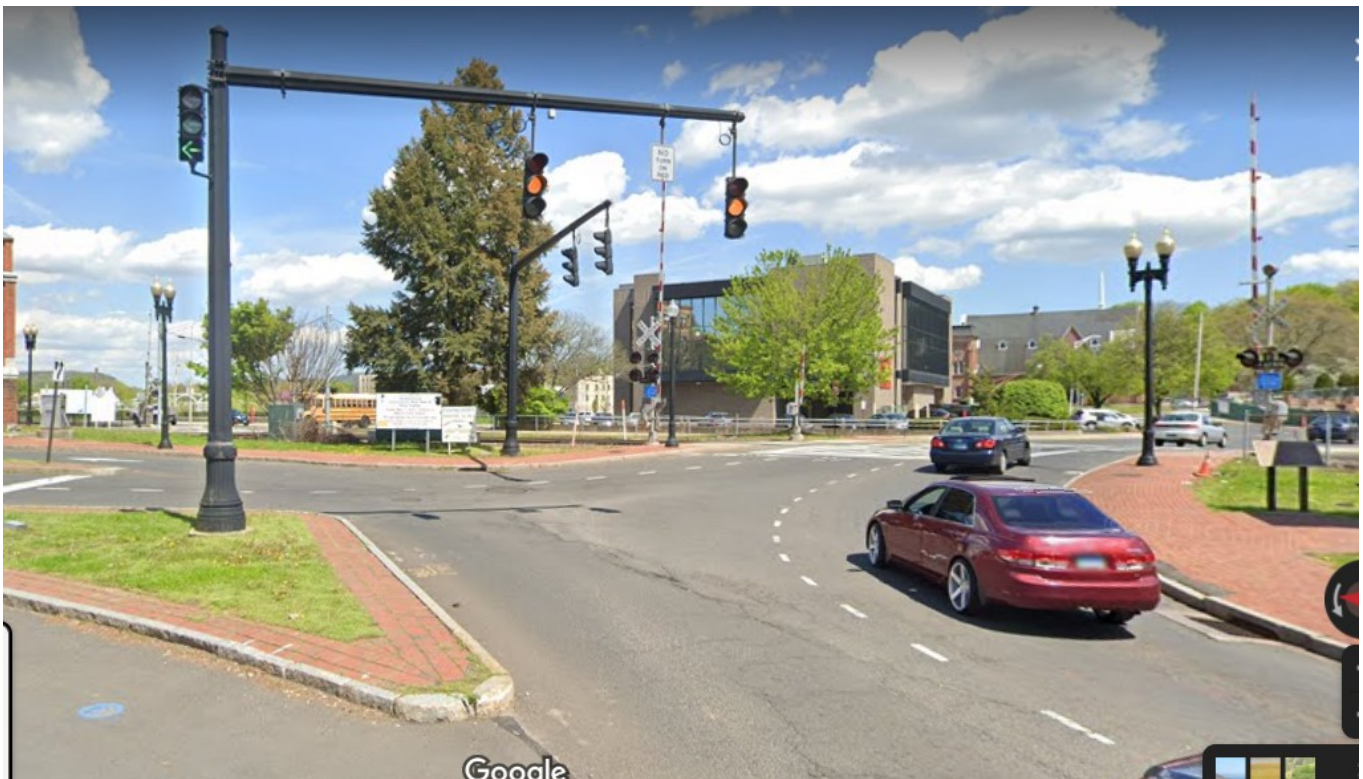
Intersection #8. Image taken from Google Street View (Image Capture May 2019)

- Two (2) span poles were metal (painted black). Five (5) light poles were metal (painted black). Five (5) traffic signals were metal (painted black). Two (2) pedestrian signal hoods were metal (painted black). One (1) traffic controller cabinet was galvanized (unpainted). Four (4) railroad crossing bar posts were galvanized (unpainted) with six (6) metal railroad lights (painted black).

- Although several elements were painted, the substrate on painted surfaces was metal; any waste generated would be classified as non-hazardous, non-RCRA waste and can be recycled.

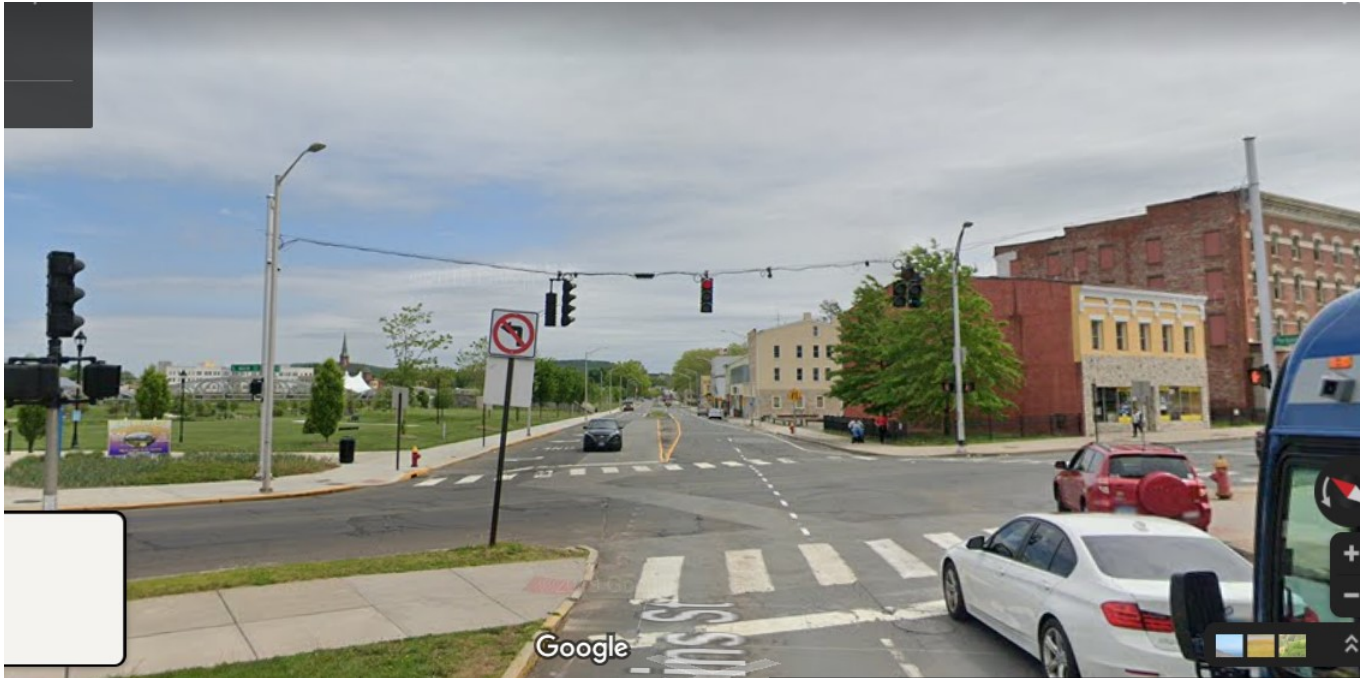
Intersection #9. Image taken from Google Street View (Image Capture May 2019)

- Two (2) span poles were galvanized (unpainted). Four (4) light poles were galvanized (unpainted). Three (3) traffic signal posts were galvanized (unpainted). Nine (9) traffic signals were metal (painted black). Ten (10) pedestrian signal hoods were metal (painted black). One (1) traffic controller cabinet was galvanized (unpainted).

- Although several elements were painted, the substrate on painted surfaces was metal; any waste generated would be classified as non-hazardous, non-RCRA waste and can be recycled.

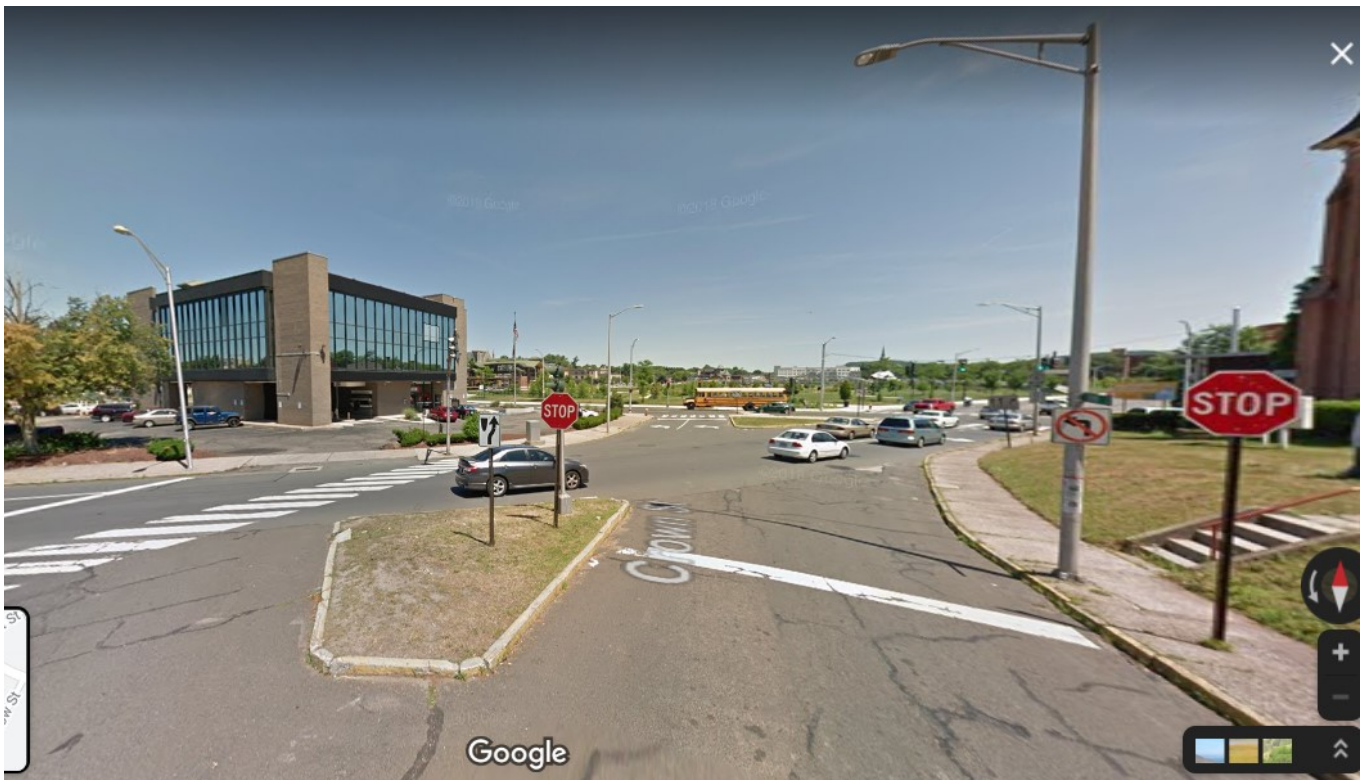
Intersection #10. Image taken from Google Street View (Image Capture May 2019)

- One (1) span pole was galvanized (unpainted). Two (2) light poles were galvanized (unpainted). One (1) traffic signal post was galvanized (unpainted). Two (2) traffic signals were metal (painted black).

- Although several elements were painted, the substrate on painted surfaces was metal; any waste generated would be classified as non-hazardous, non-RCRA waste and can be recycled.

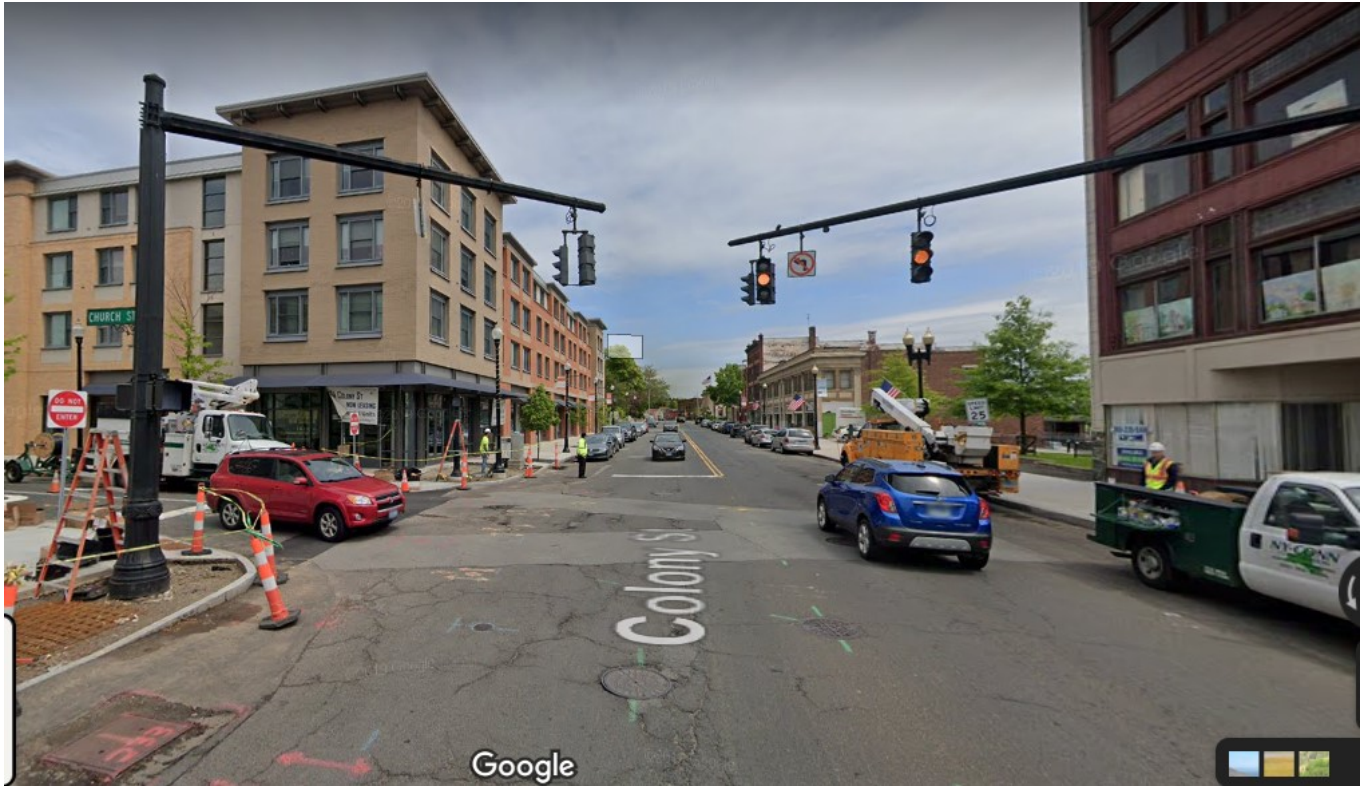
Intersection #11. Image taken from Google Street View (Image Capture May 2019)

- Two (2) span poles were metal (painted black). Six (6) traffic signals were metal (painted black). One (1) pedestrian signal pedestal was metal (painted black), and six (6) pedestrian signal hoods were metal (painted black). Four (4) light poles were metal (painted black). One (1) traffic controller cabinet was galvanized (unpainted).

- Although several elements were painted, the substrate on painted surfaces was metal; any waste generated would be classified as non-hazardous, non-RCRA waste and can be recycled.
